AIRMUNITIONS TEST REPORT

SERVICEABILITY TEST OF CONTINUITY
TEST STAND USED WITH THE 2.75 INCH
FOLDING FIN AIR ROCKET

2705TH AIRMUNITIONS WING
OGDEN AIR MATERIEL AREA
AIR FORCE LOGISTICS COMMAND
UNITED STATES AIR FORCE
Hill Air Force Base, Utah

00Y-TR-61-51

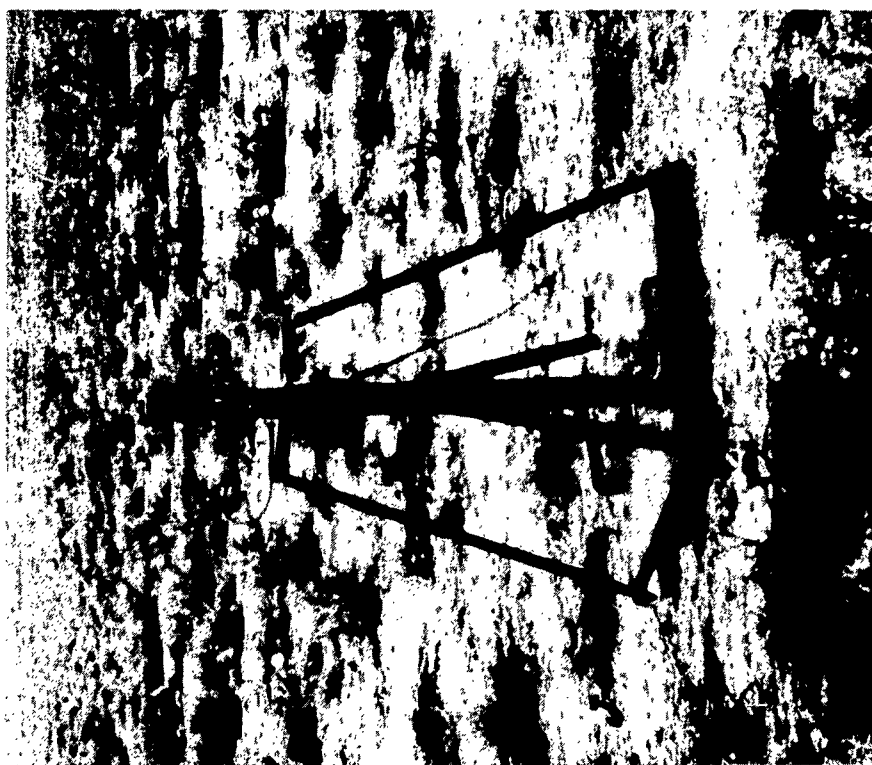
FIGURE 2. Single Rocket Test Set-Up Using Inert or H.E. Warheads.

A single rocket with an inert head, was placed in the center position of the stand (Figure 2). After attaching the connecting wires and continuity checking, the motor was functioned.

A single rocket, with a high explosive head, was placed in the Number 2 position as shown in Figure 2. After attaching the connecting wires and continuity checking, the motor was functioned.
